# Manhole Inspection Summary

Manhole # S09CC2009MH

**Location** Address: **5866 CROSS COUNTRY RD** Cross Street: **GREENSPRING AVE**

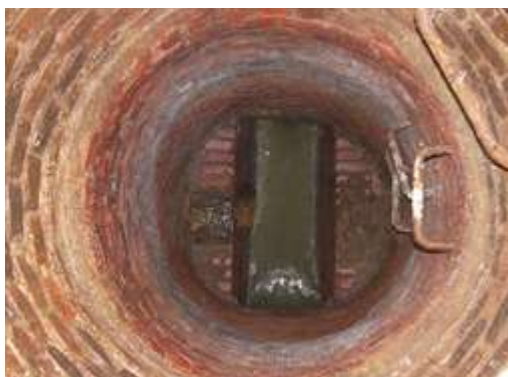
Top View

corroded steps, adjustment infiltration, corbel infiltration

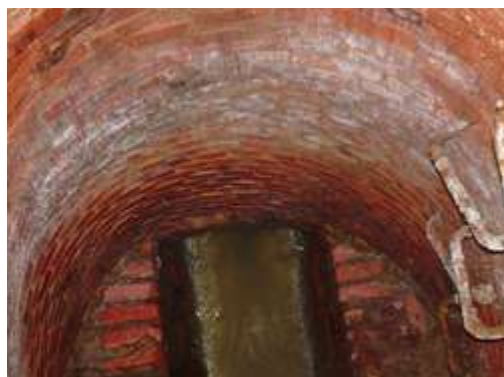
Defect

Barrel infiltration.

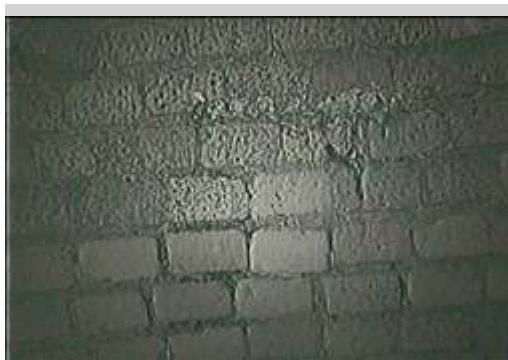
Defect

Corbel infiltration.

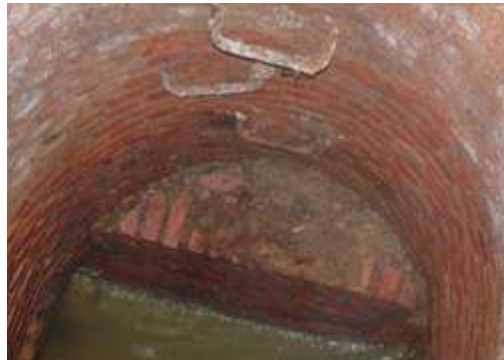
Defect

corroded steps, Evidence of surcharge. bench debris

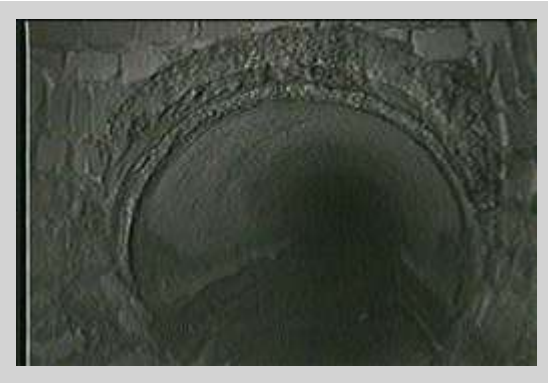
### 24 in. Circular Gravity Sewer Pipe Out @ 12 O'Clock

Infiltration: **Weeper** Pipe Seal Cond: **Unknown**

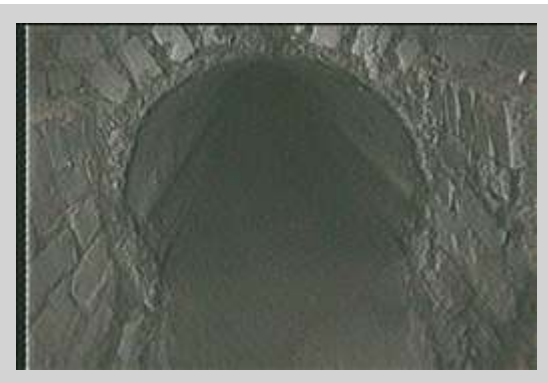
### 24 in. Circular Gravity Sewer Pipe In @ 6 O'Clock

Infiltration: **Weeper** Pipe Seal Cond: **Cracked**

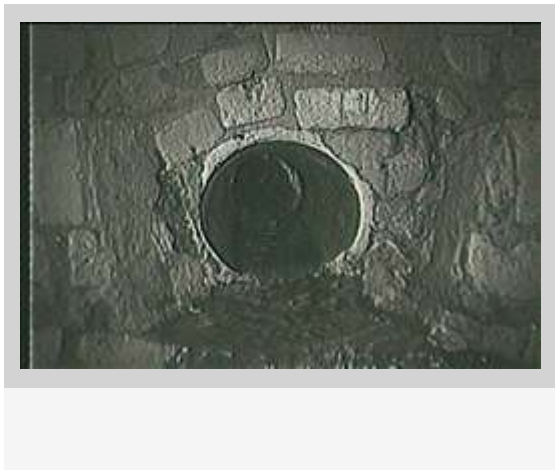
8 in. Circular Gravity Sewer  
Pipe In @ 9 O'Clock

Infiltration: **Evidence** Pipe Seal Cond: **Unknown**
